Coordination Meeting

07/22/2021

Corral Damage

TSSD Utah Lake Limn

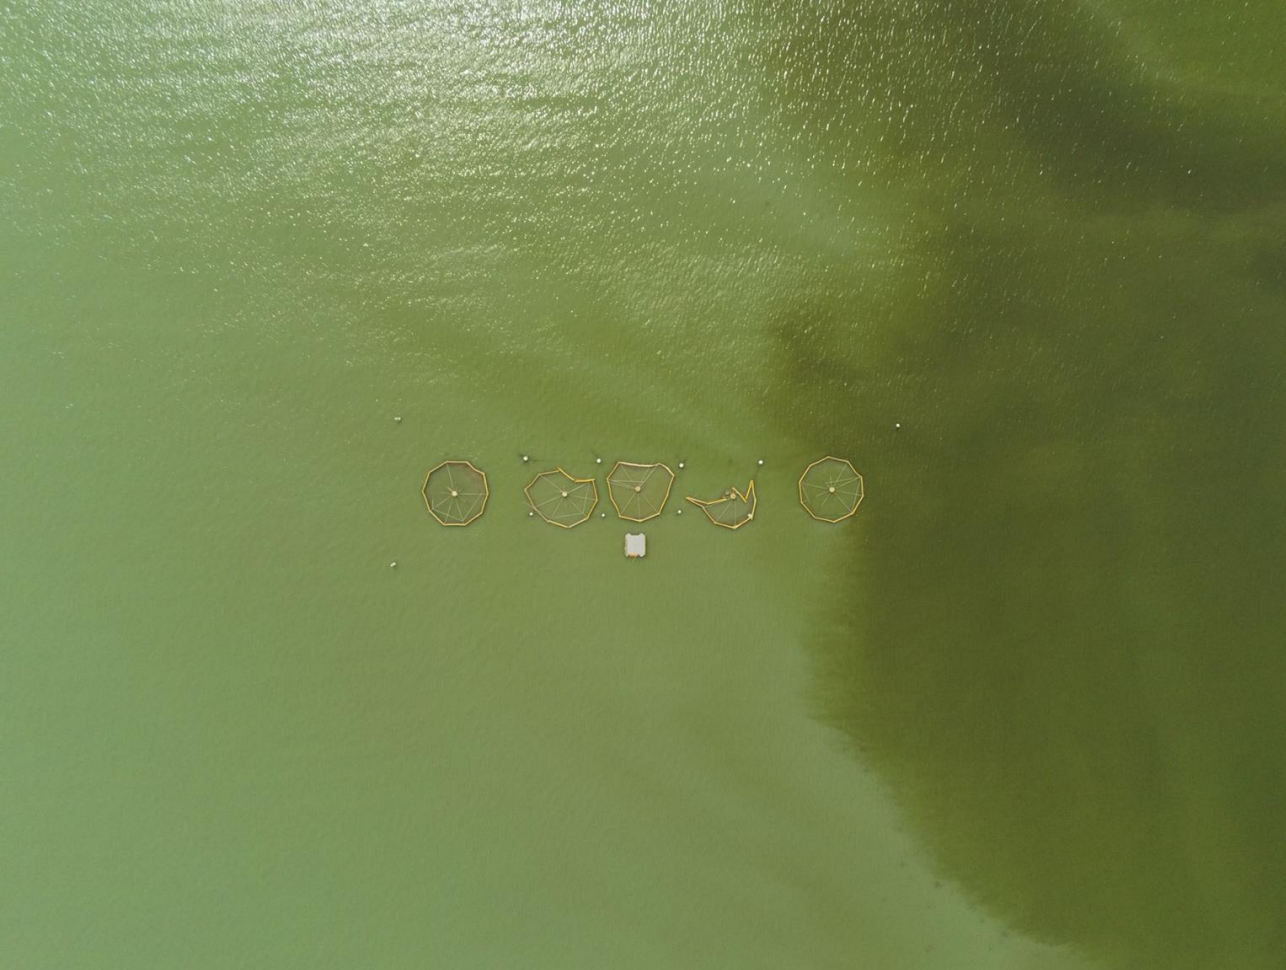
06/14

- More turbid water on the side with tear in skirt

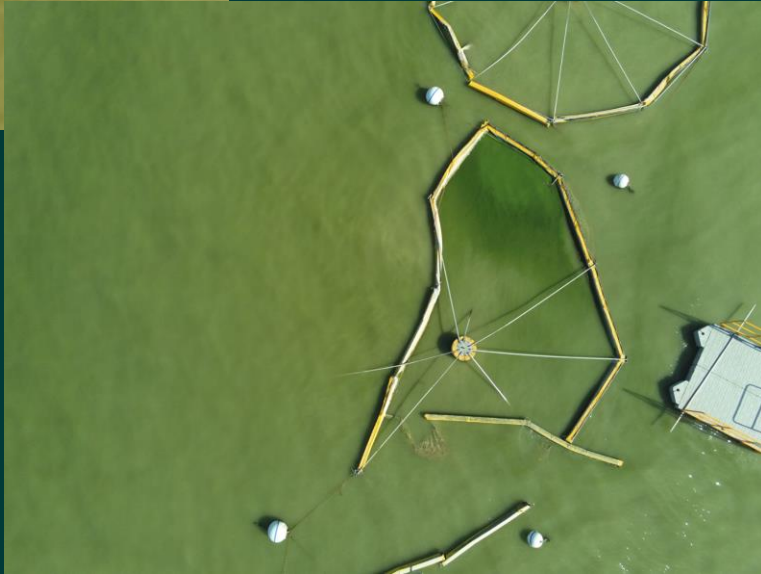
07/16

- Significant blooms inside of corrals, mostly on North and East ends
- Excess skirt creating shallow pockets of warmer water
- Dolichospermum and others

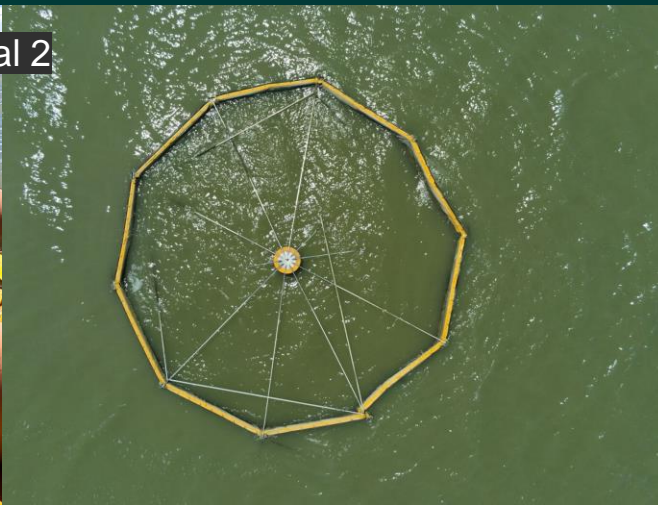
06/29

- Struts ripping the skirts
- Rip in Corral 2 skirt is about 3 feet long
- Rip in Corral 5 skirt is from the surface to the bottom

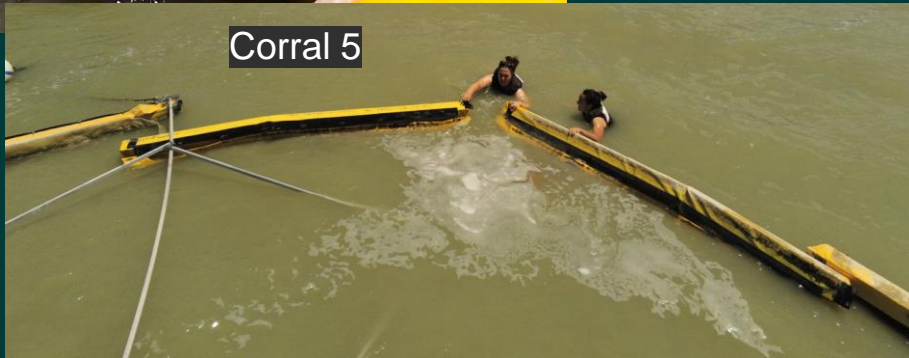
Corral 5

07/21

- stitching connecting the tarps to the floats is unraveling (all corrals)

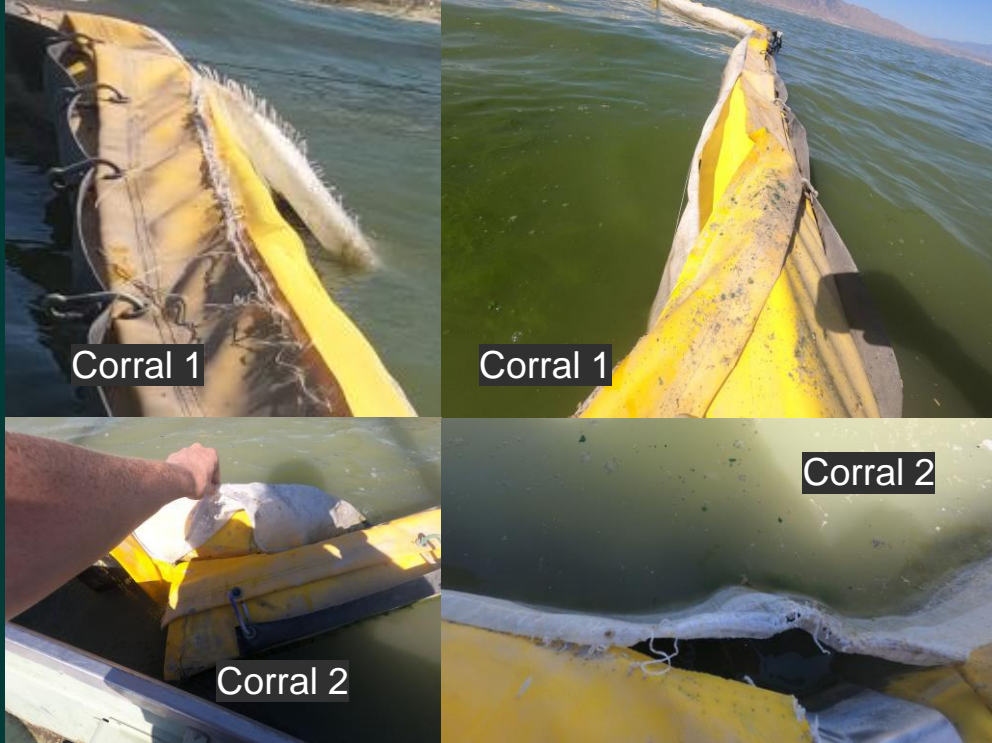
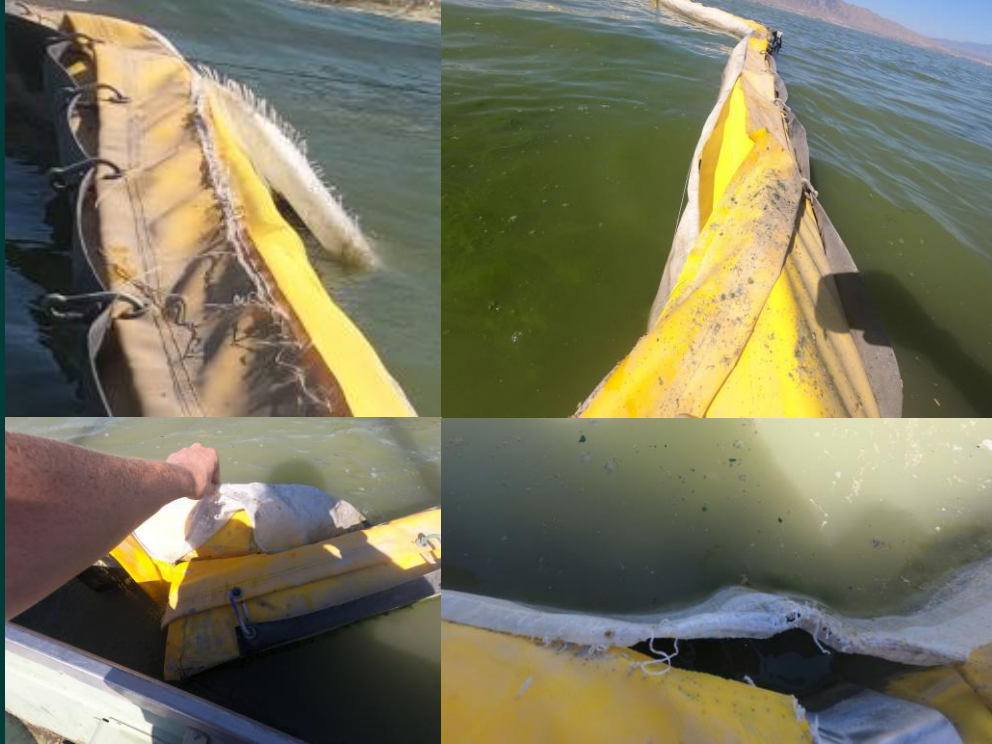
07/21

- stitching connecting the tarps to the floats is unraveling (all corrals)

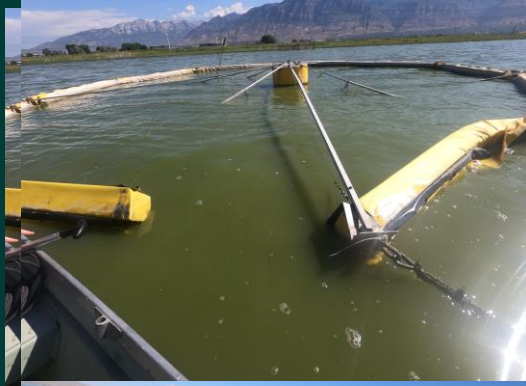
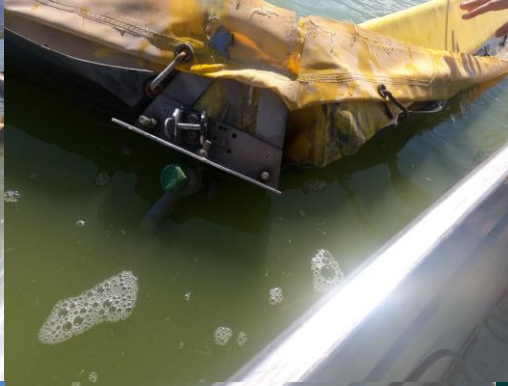
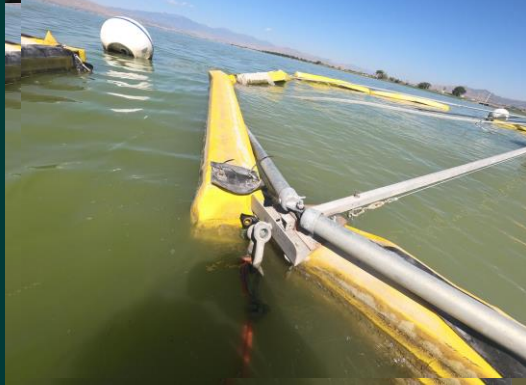
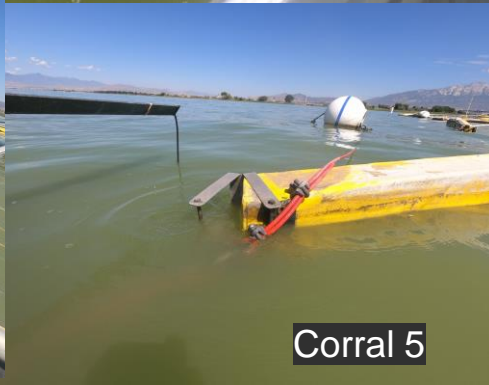
07/14

- tried to repair with extra strong waterproof tape
- corrals were too wet for the tape to cure despite scrubbing and drying the floats and tarp

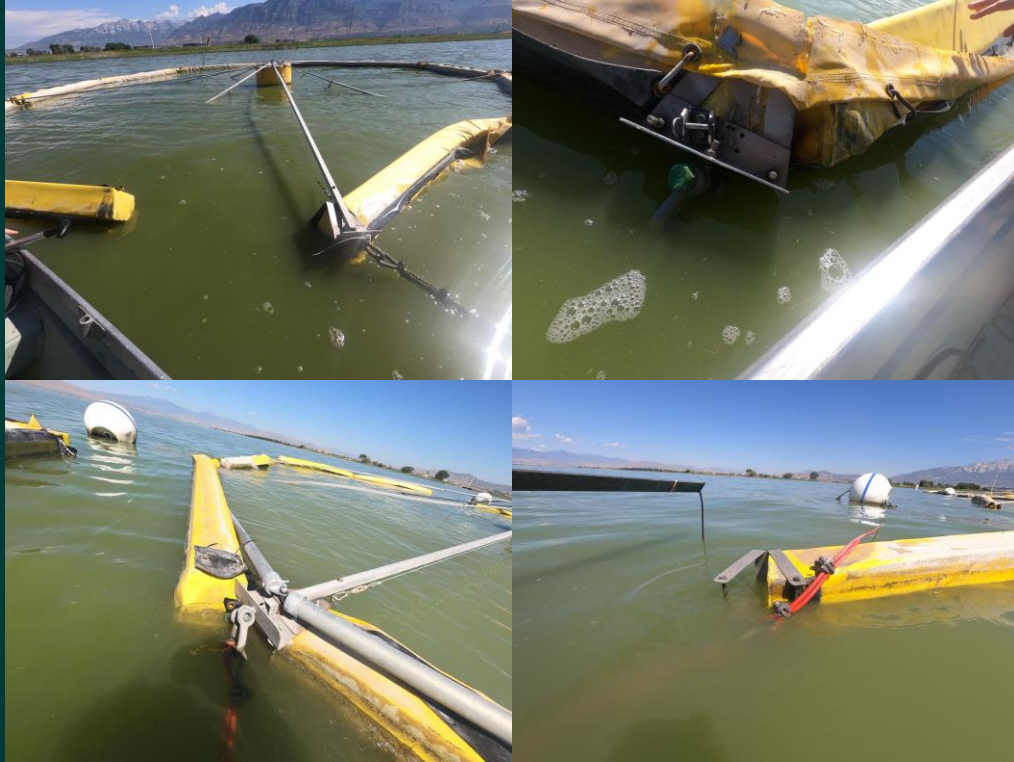
Corral 5

07/21

- brackets failing to hold floats in place

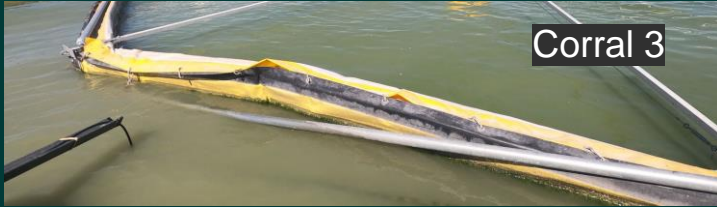
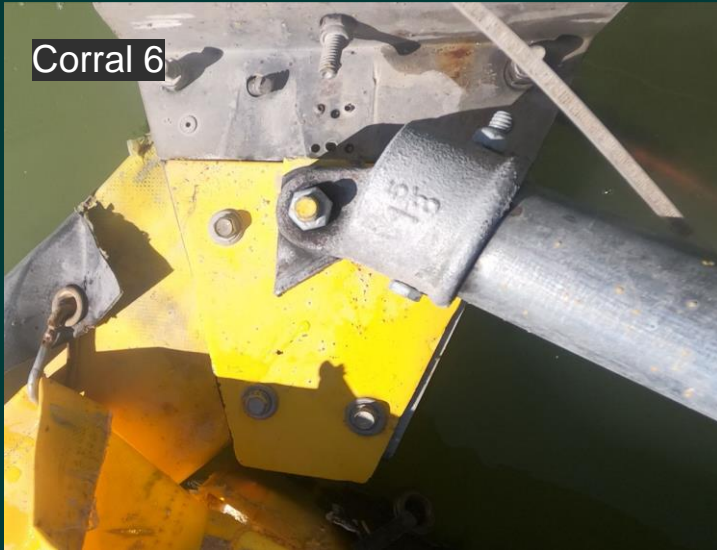
07/21

- brackets failing to hold floats in place

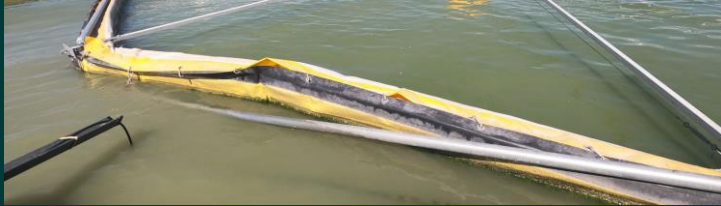
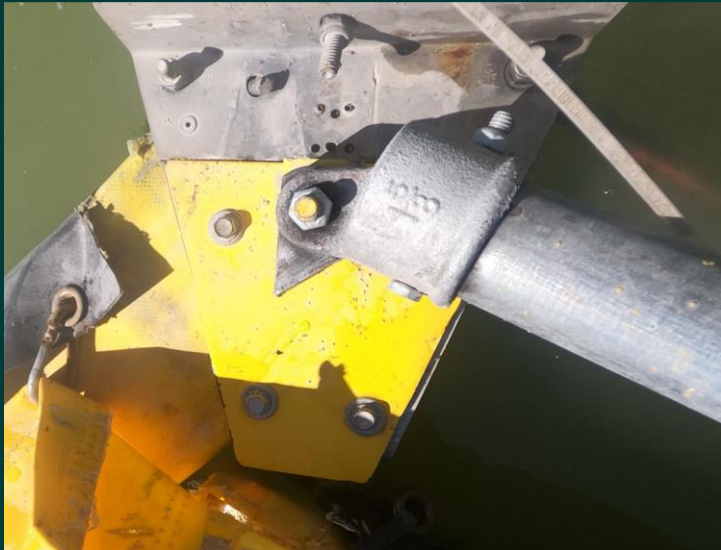
07/21

- Reinforcement bars on Corrals 3 and 5 snapped at the joints
- Some are still attached, others sank

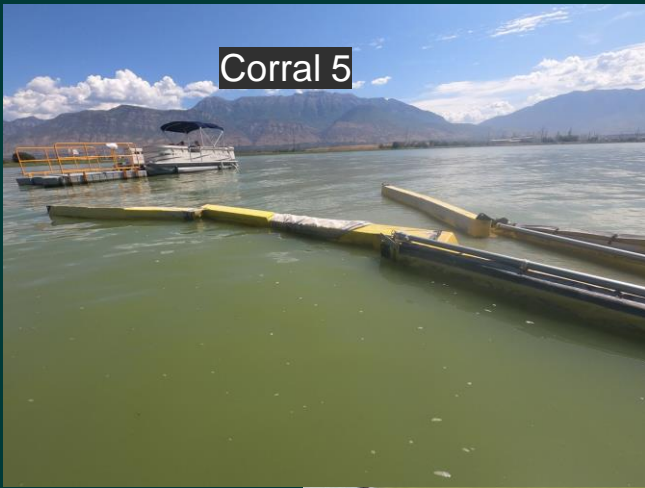
Corral 5

07/21

- Reinforcement bars on Corrals 3 and 5 snapped at the joints
- Some are still attached, others sank

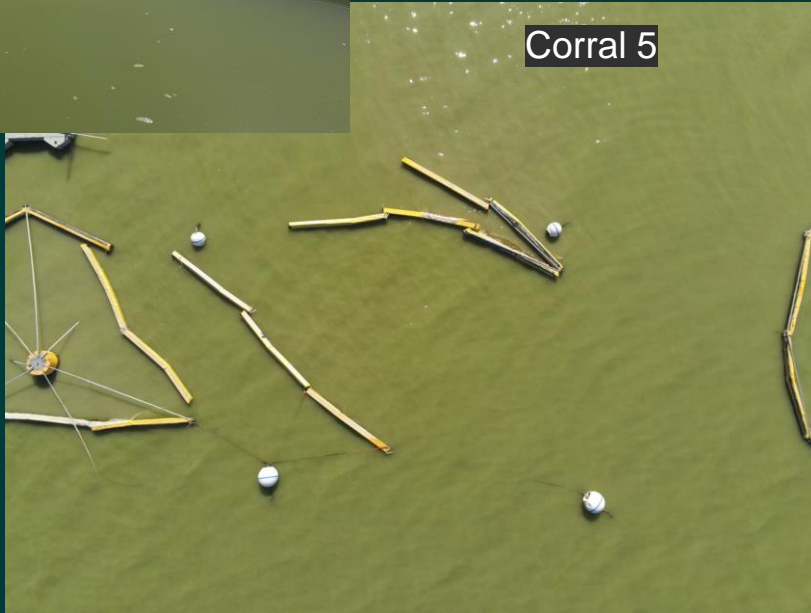
07/21

- Corral 5 is missing 2 yellow floats since July 15th
- Most of the skirt is disconnected from the floats
- All reinforcement bars are gone
