End of Season Limnocorral Damage Report: *Utah Lake Nutrient Cycling Studies*

November 26th, 2022

Utah Nutrient Cycling Studies: End of 2022 Season Corral Damage Report

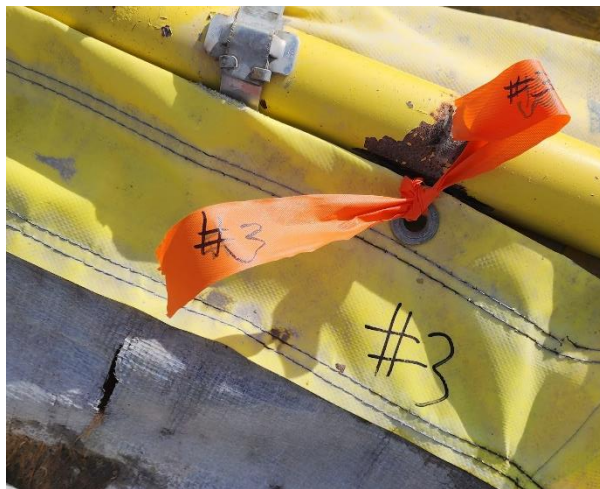
Figure 2 Corral Skirt and Rip Labeling System

Each skirt was labeled 1-9 with orange construction tape and sharpie (Figure 2). This same method was used to identify locations with the holes and rips around the corral. Overall, 3 skirts

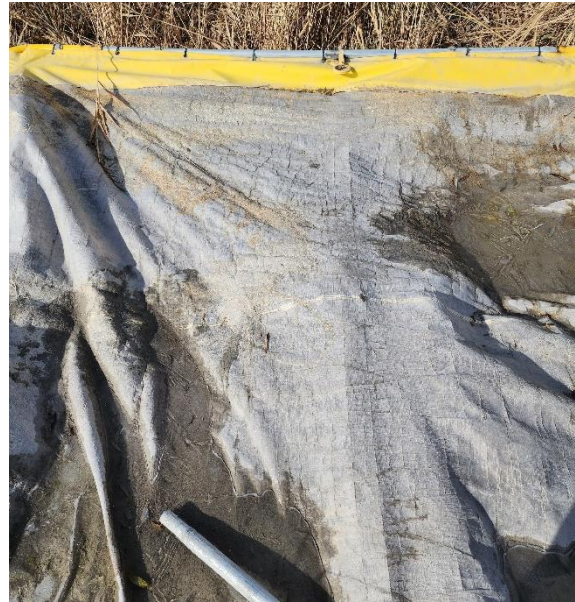
Figure 3 Corral #1 Wear and Tear

Corral #1 had no visible rips or holes in it, just normal wear and tear (Figure 3). The corral was covered in algae and mud and could use a power wash. Overall, this skirt is in good condition and could be reused for the 2023 sampling season.

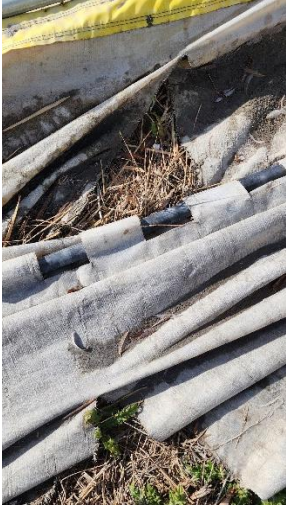
6ft

Corral #2 had 5 holes. We recommend that this corral skirt be replaced. One of the holes spanned the length of the corral skirt. We are unsure when this rip happened but believe that it may have occurred in the process of moving the corral to shore. The significant rip is not along a seam and as such would be difficult to repair.

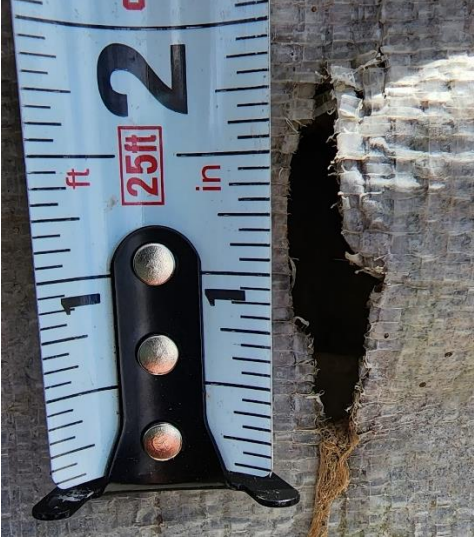
Rip Size	Picture
2in

Corral #3 was tied up and as such was hard to thoroughly inspect for rips. We were still able to identify 6 rips in the skirt. This was one of the skirts that was left rolled up on shore for winter storage.

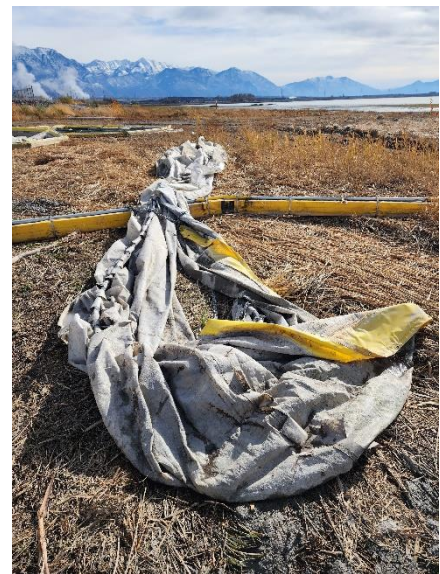
Corral #4 seemed as though a truck was used to pull it out. It was pulled across the grass and as such was difficult to thoroughly inspect. No rips were easily spotted. It seemed as though this skirt had some wear and tear and would only need to be power washed for next year's sampling schedule.

Figure 4 Corral #4 Skirt
When the BYU Students
Arrived

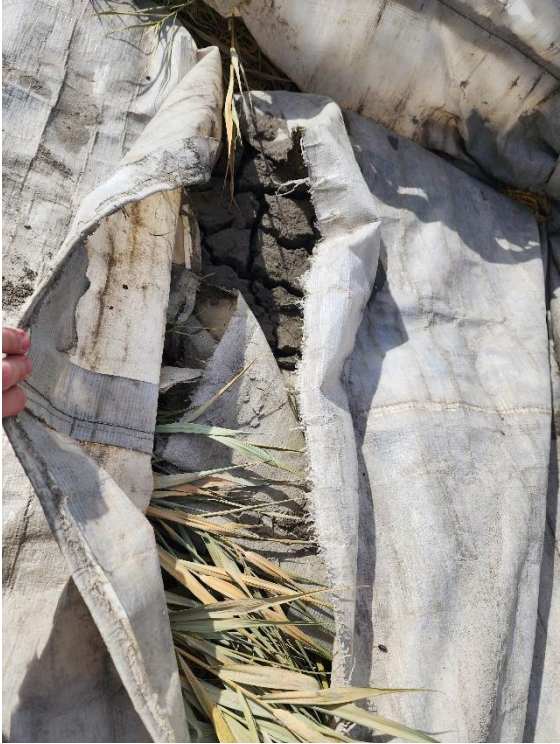
4ft +

Corral #5 inspected found 2 significantly sized holes in the skirt and many smaller holes from wear and tear. The biggest rip (4ft +) is along a seam and has potential to be repaired.

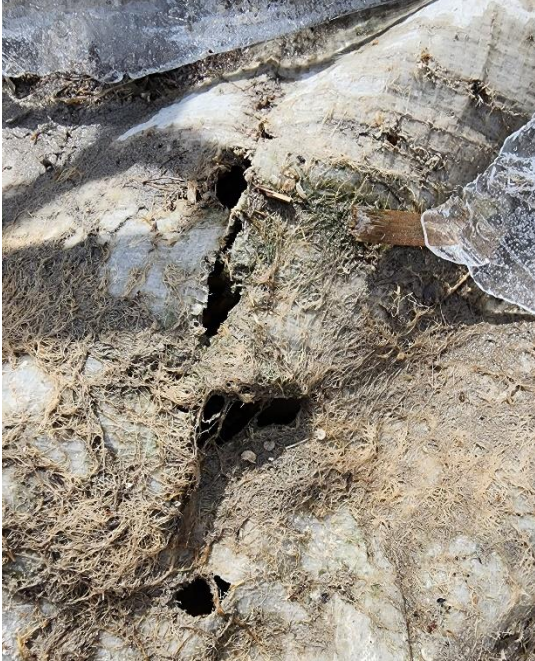
Rip Size	Picture
Three holes spanning 5in

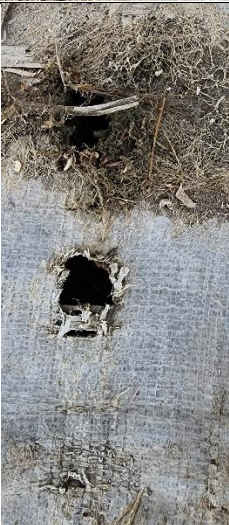
Two Holes Spanning 3.5in (a third hole beginning to wear)

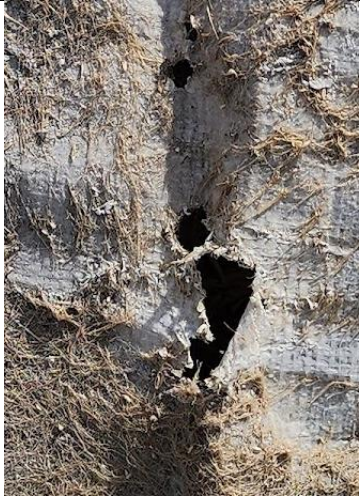
Three holes spanning 4in

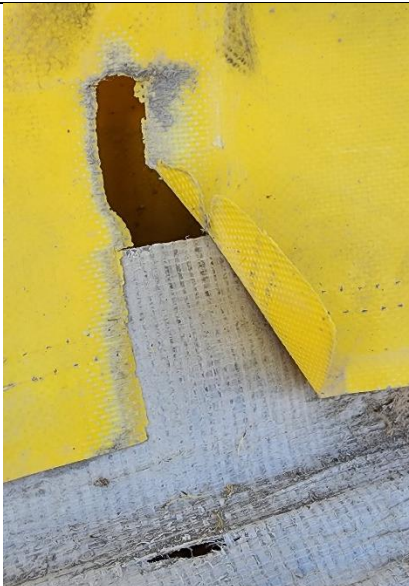
Rip Size	Picture
4in

Corral #7 only had one visible rip in the top yellow part of the limnocorral. This corral would benefit from being washed. It can be used next season.

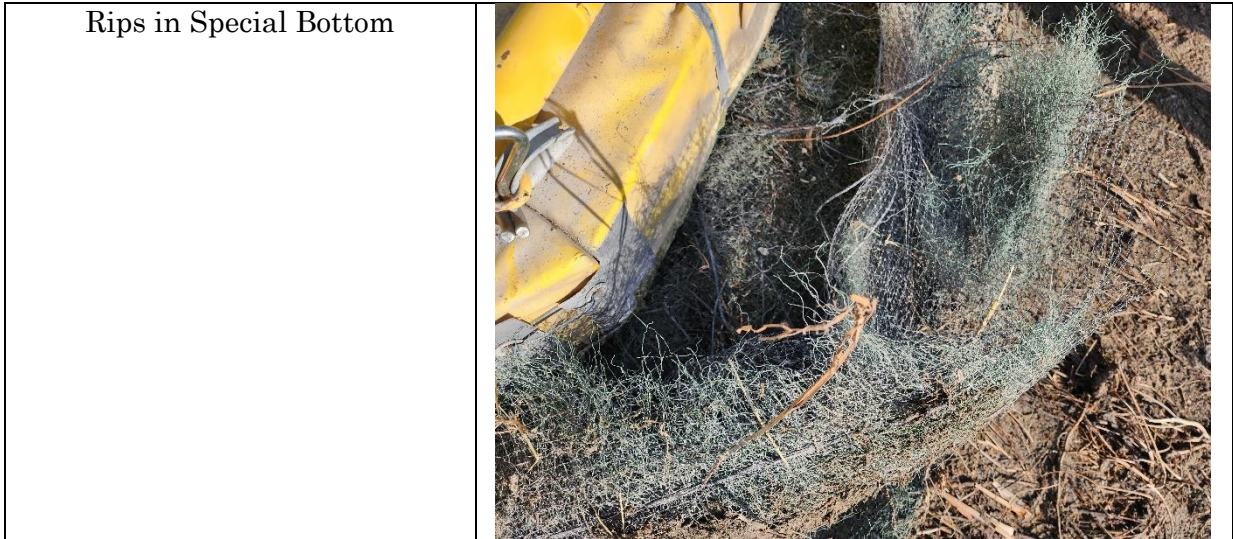
Corral #8 was the skirt with the special bottom to reduce the sediment mixing within the corral. The bottom part of the skirt was ripped off and there was plenty of missing fill for the skirt. The skirt was replaced in the middle of the sampling season and has no rips in the skirt. The bottom of the skirt has a lot of mud in it, making it extremely heavy and hard to work with.

Rip Size	Picture
<p>Missing Filling from the Special Bottom</p>

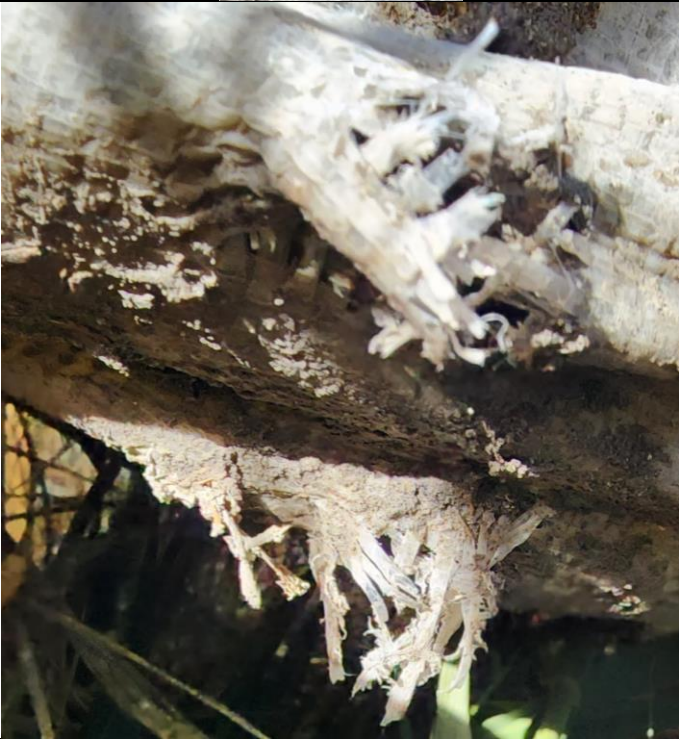
<p>2 holes 1.5in each</p>

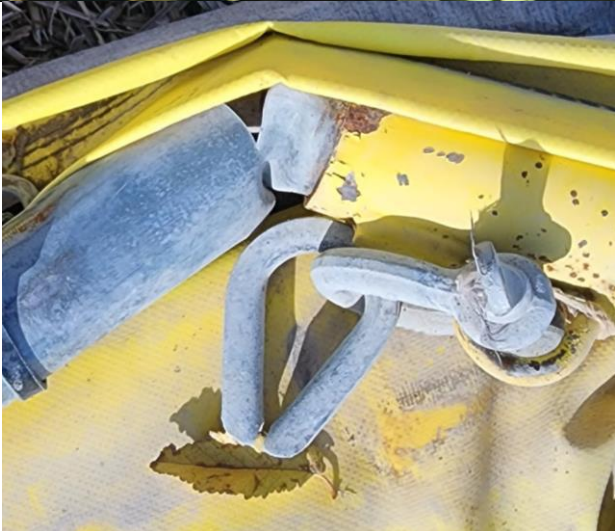
Corral #9 was hard to fully inspect because it was tied up. We were still able to find four holes in the skirt. The algae on this skirt have fully dried off and could be easily brushed or ripped off. In addition to the holes in the skirt in this limnocorral the reinforcement bars on the floats have been damaged.

<p>Limnocorral Damage</p>
