End of Season Limnocorral Damage Report: *Utah Lake Nutrient Cycling Studies*

November 26th, 2022

Utah Nutrient Cycling Studies: End of 2022 Season Corral Damage Report

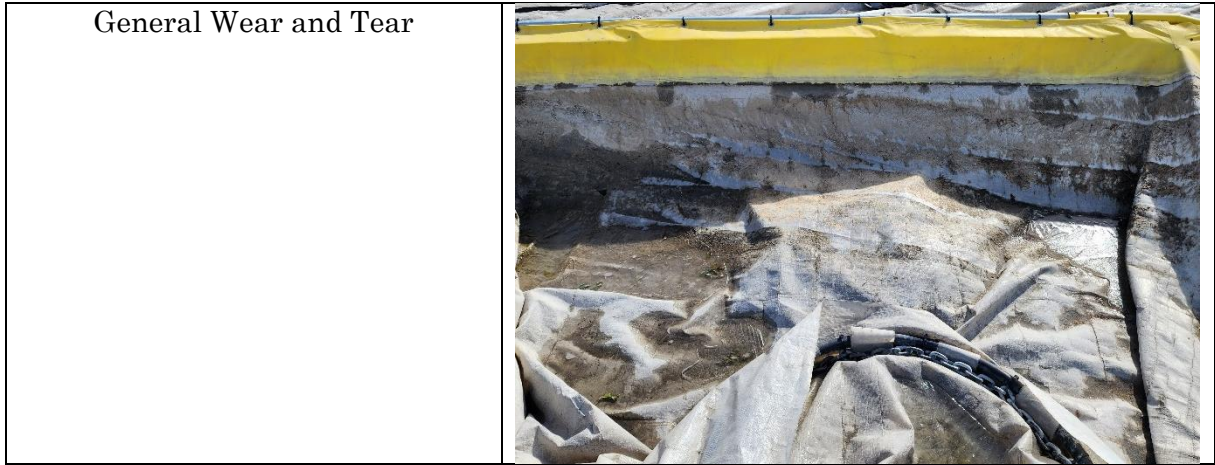
Corral #7 only had one visible rip in the top yellow part of the limnocorral. This corral would benefit from being washed. It can be used next season.

Rip Size	Picture
4in
