# Coordination Meeting

## 07/07/2021

# Corral Skirt Inspection

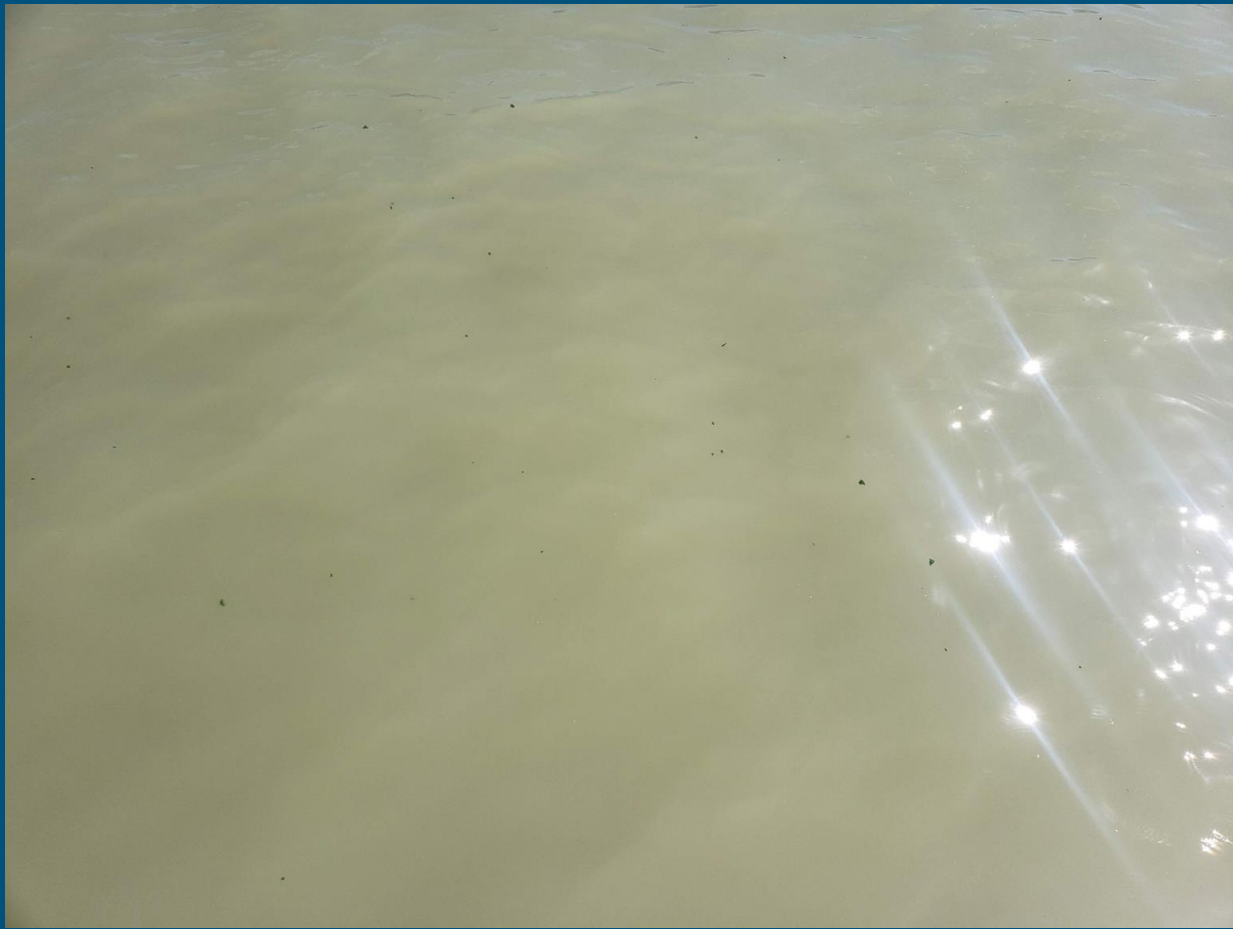
Algae in the water on Friday, July 2nd. We didn't see any south of the corrals (further out in the lake) but there was a lot around the corrals and towards the shore.

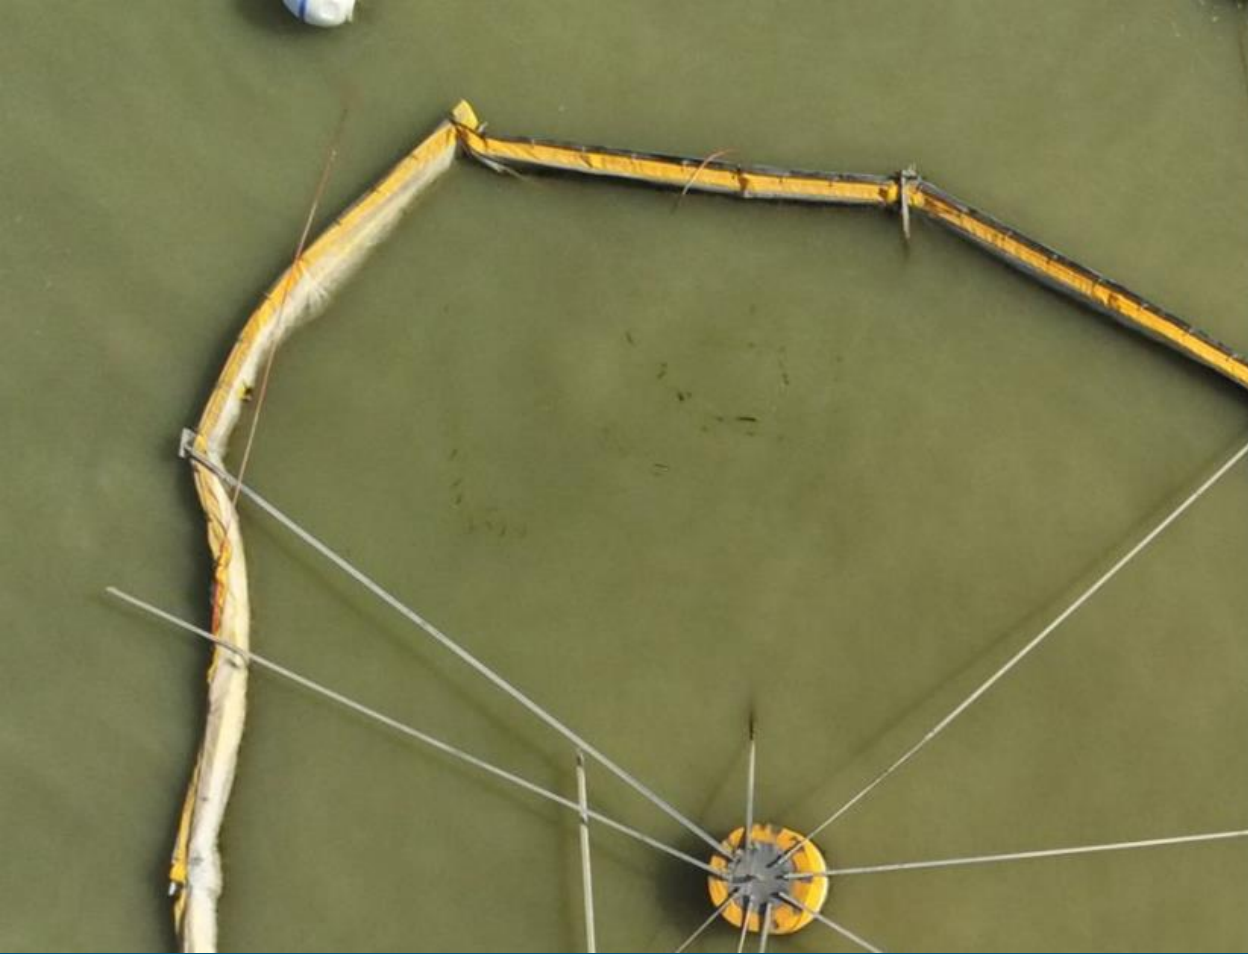
Algae in Corral 3 on Monday July 5th. There was none in any of the other corrals. The algae spots that we saw on Friday outside the corrals were gone today.

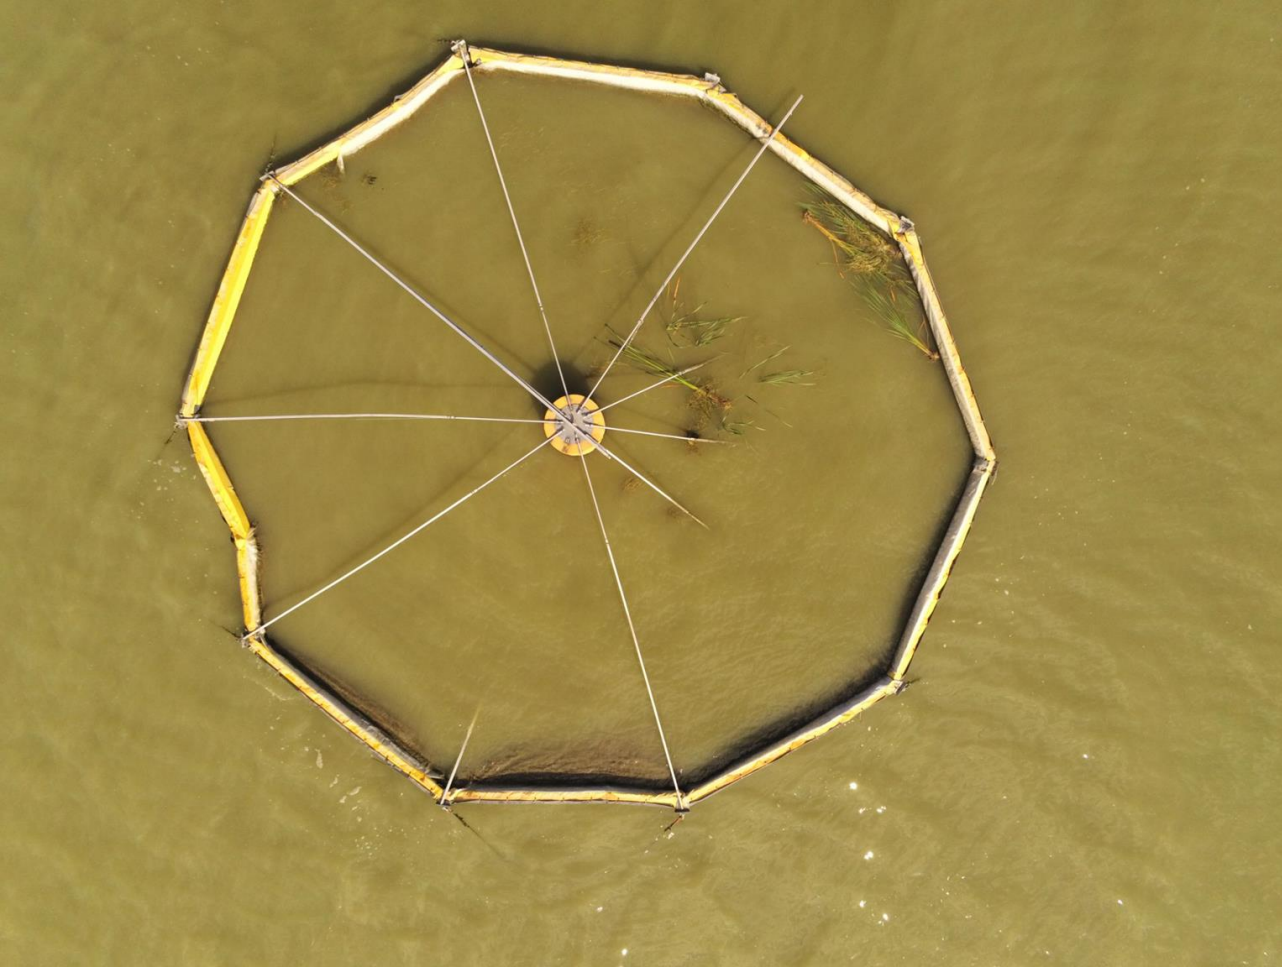
Vegetation in Corral  
1 on July 5th.

Looks like carp are  
up-rooting plants
